# Evaluation Report

## Versatile Model 480 Field Sprayer

A Co-operative Program Between

# Versatile Model 480 Field Sprayer

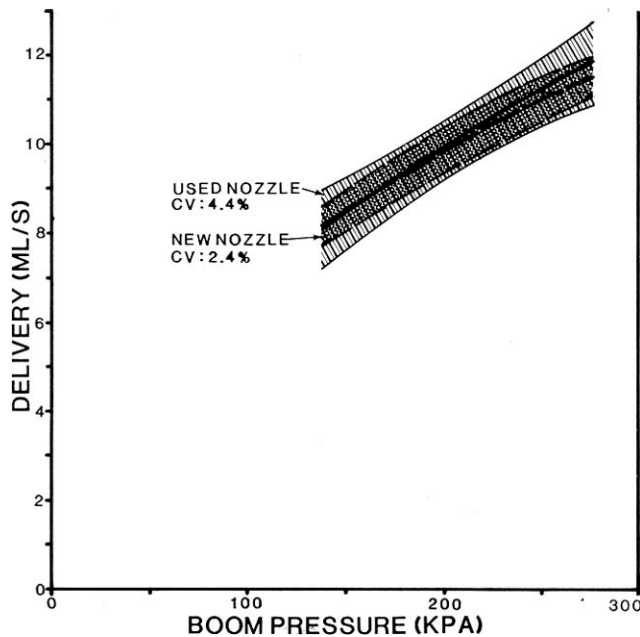
**Figure 5.** Delivery Rates of TeeJet 8002 Nozzles - New and Used 52 Hours.

**Nozzle Calibration and Wear:** Figure 5 compares the delivery rates of the stainless steel TeeJet 8002 nozzles when new and after 52 hours of operation. Delivery from the nozzles increased by only 0.6% after 52 hours. Some researchers indicate that a nozzle needs replacement once discharge has increased by more than 10%.

Figure 5 also shows the variability in delivery rate among individual nozzles. The shaded areas represent the range over which the deliveries from 10 nozzles varied when new and after field tests. A narrow range indicates that nozzle discharges are very similar while a wider range indicates a higher variability among individual nozzle deliveries. Variability among individual nozzle deliveries on the Versatile 480 was low. The coefficient of variation of the nozzle deliveries was 2.4% when new and increased to 4.4% after the field tests.

The delivery from new nozzles was 7.7% lower than the manufacturer's rated capacity. This was due to the nozzle check valves which caused a 35 kPa (5 psi) pressure drop from the boom to the nozzles.

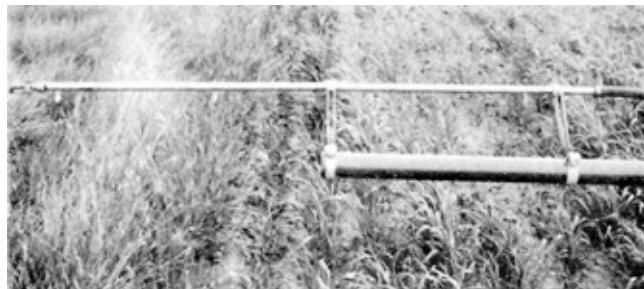
**Figure 11.** Unsupported Boom Ends.

Measurement of boom stability and field observations indicated that boom whip was excessive along its entire length. More severe boom movement occurred at the unsupported boom ends (Figure 11).

1. Modifications to reduce boom whip.
2. Modifications to eliminate braking of the outer boom uprights.
3. Supplying a high capacity 100 mesh strainer at the tank irdler opening.
4. Providing a platform to facilitate safe and convenient addition of chemicals to the tank.
5. Modifications to reduce transport width.
6. Supplying a slow moving vehicle sign.
7. Modifications to eliminate tank strap breakage.
8. Modifications to eliminate loosening of the rocker axles during operation.
9. Supplying a torque arm to prevent the pump body from rotating with the power take-off.
10. Supplying a metric or dual calibrated pressure gauge, or suitable conversion charts to facilitate sprayer operation after conversion to the SI system.
11. Using consistent units in the operator's manual.

1. A bolt on boom truss has been designed for 1977 production and is also available for the 1976 model 480.
2. Boom uprights are now fabricated from formed channel. These are interchangeable with boom uprights on all 1976 models.

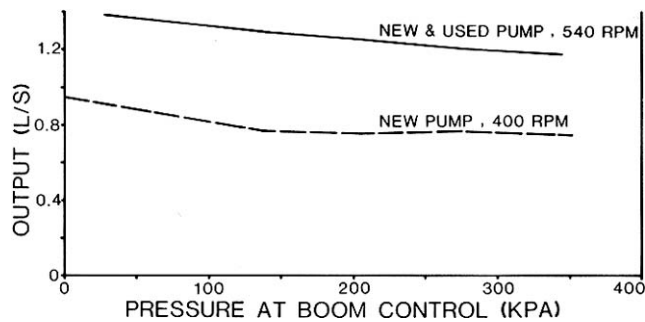
Figure 12. Pump Curves.

**Agitation Capability:** The pump, when new, had a delivery rate of 1.2 L/s (15.8 gal/min) at 276 kPa (40 psi) and 540 rpm (Figure 12). This was adequate to apply 156 L/ha (13.9 gal/ac) of emulsifiable concentrates or 61 L/ha (5.4 gal/ac) of wettable powders at 8 km/h (5 mph) and provide sufficient agitation to keep the solution in the tank properly mixed. Normally recommended agitation rates for emulsifiable concentrates such as 2,4-D are 0.03 L/s per 100 L of tank capacity (1.5 gal/min per 100 gal of tank capacity). For wettable powders such as Atrazine and Sevin, recommended agitation rates are 0.05 L/s per 100 L of tank capacity (3.0 gal/min per 100 gal of tank capacity).

If a pump wear allowance of 20% is assumed, a worn pump could apply and agitate 113 L/ha (10.1 gal/ac) of emulsifiable concentrates or 19 L/ha (1.7 gal/ac) of wettable powders. The pump was adequate for most chemicals when new, but was inadequate for wettable powders, when worn.

**Operation at Reduced Speed:** Figure 12 also shows that reducing pump speed from 540 to 400 rpm resulted in a 37% decrease in pump output. Reduction of pump speed could occur when reducing the tractor speed for corners or when operating at reduced engine speed to obtain a correct ground speed to suit nozzle calibration.

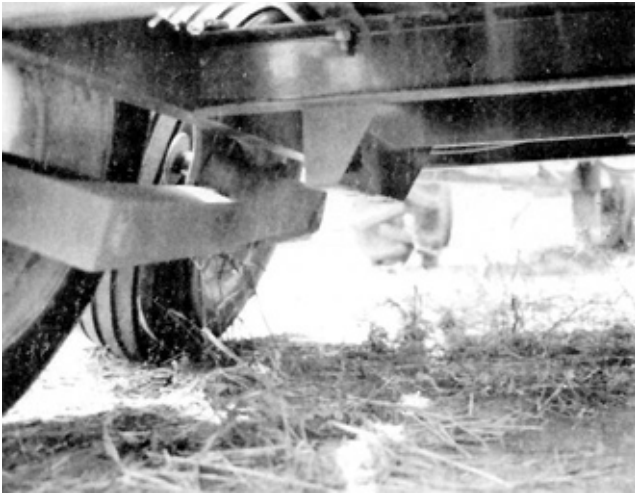
Figure 17. Damage to Rocker Axle.

- the left rear tank strap broke and was welded at	12, 36	227, 682 (561)(1684)
- the right rear tank strap broke and was welded at	14	265 (655)
-the roll pin on the left rocker axle assembly loosened, causing main frame and tire damage at	43	814 (2012)

**Rocker Axles:** The left tandem rocker axle loosened because the roll pin holding the rocker axle fell out. The rocker axle moved outwards causing the outer axle bracket to bend (Figure 17). This also damaged the tires. The roll pin on the right rocker axle also fell out but was replaced before damage occurred. Modifications are required to prevent the rocker axles from loosening.

8. The retaining pin hole in the rocker axle pivot has been sized to provide a tight fit for the roll pin.
9. The pump now has a torque arm and tie chain as standard equipment.

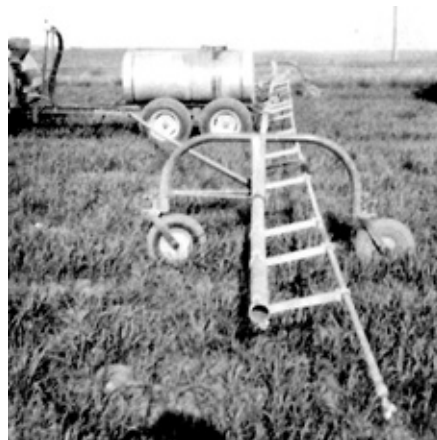
Figure 19. Bowed Boom Support Tube.

- a complete nozzle assembly was lost and replaced at	39	739 (1825)
- the boom support tube was bent back slightly at	39	739 (1825)
- the left boom universal joint was bent at	40	758 (1872)

**Boom Support Tubes:** The boom support tubes deformed slightly (Figure 19). This occurred under normal field operation due to the opposite forces on the boom support tube from the radius brace and castor wheels. Functional performance of the sprayer was not affected by bowing of the booms.

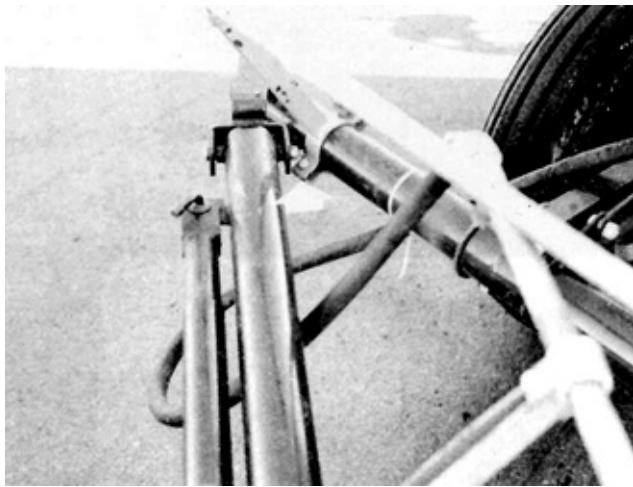
**Figure 20.** Short Turn in Transport causing Bending of the Boom Universal Joint.

**Universal Joint:** The left boom universal joint was bent as a result of interference when turning too short (Figure 20). Bending of the universal joint did not affect sprayer operation.
